Application of Protective Coating for Rehabilitation of Wisconsin Concrete Bridges

Al Ghorbanpoor, University of Wisconsin-Milwaukee

PACE 2008 Conference – Los Angeles, CA, January 2008

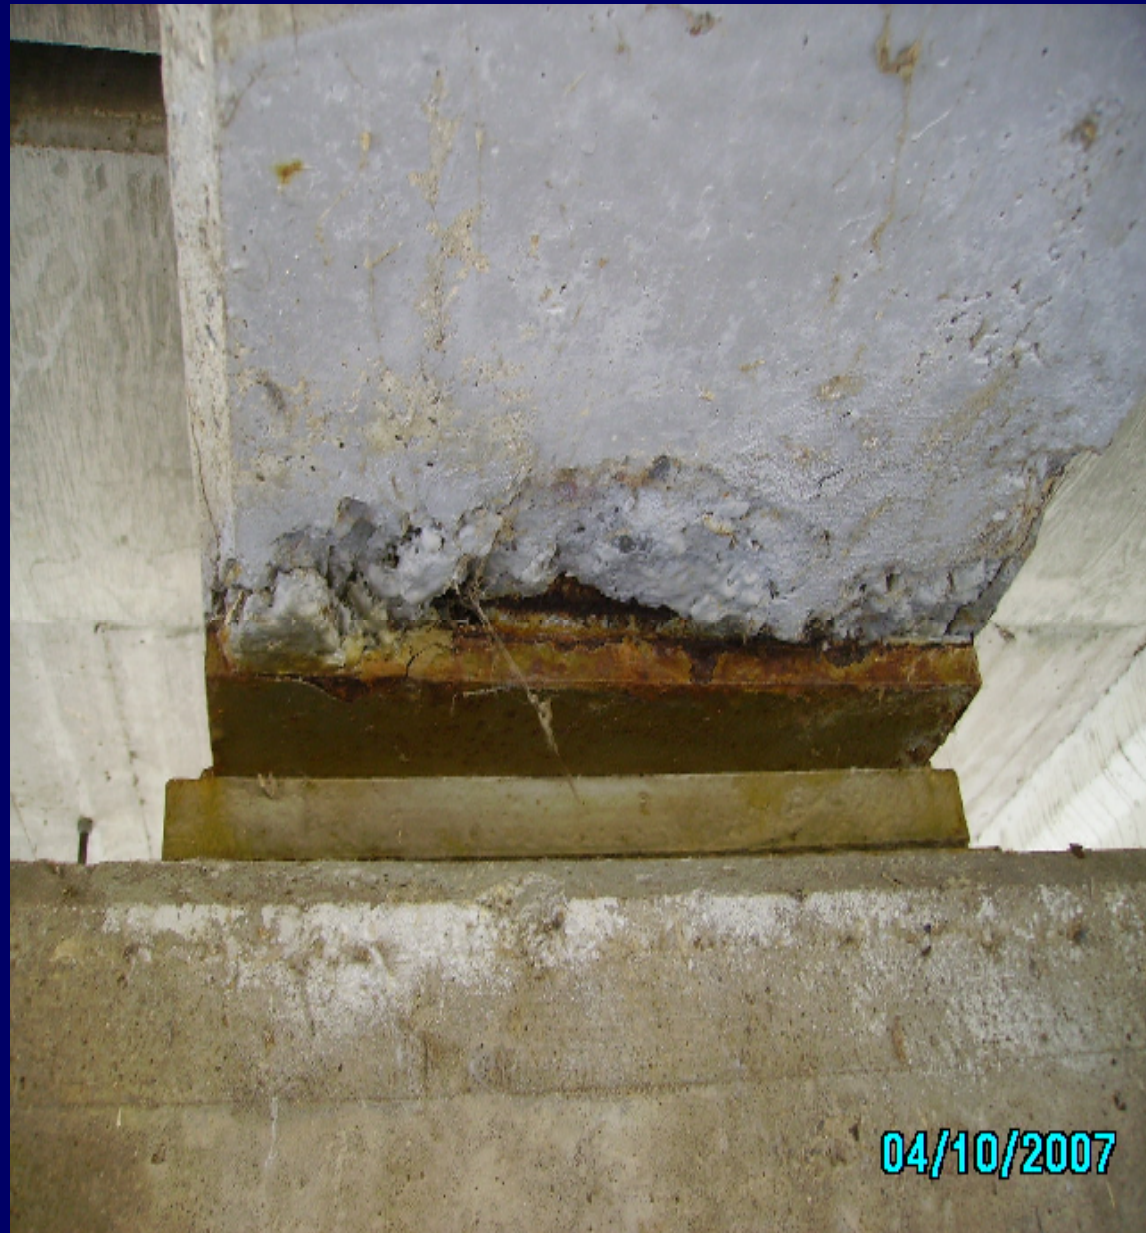
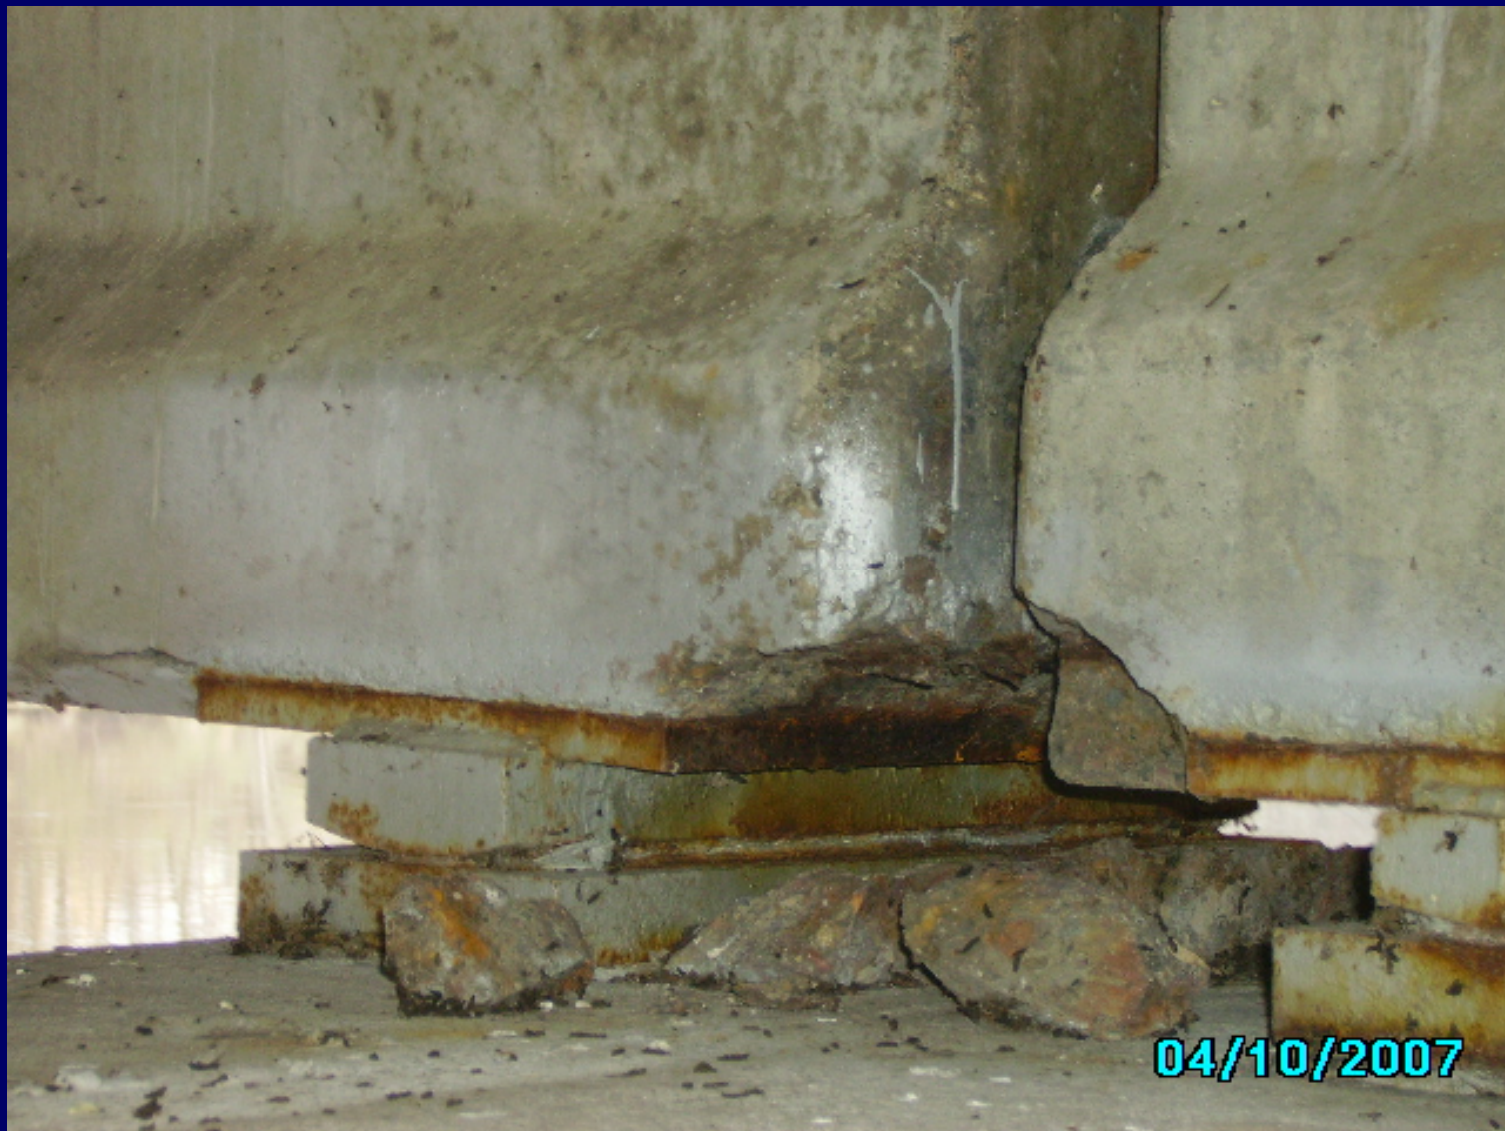
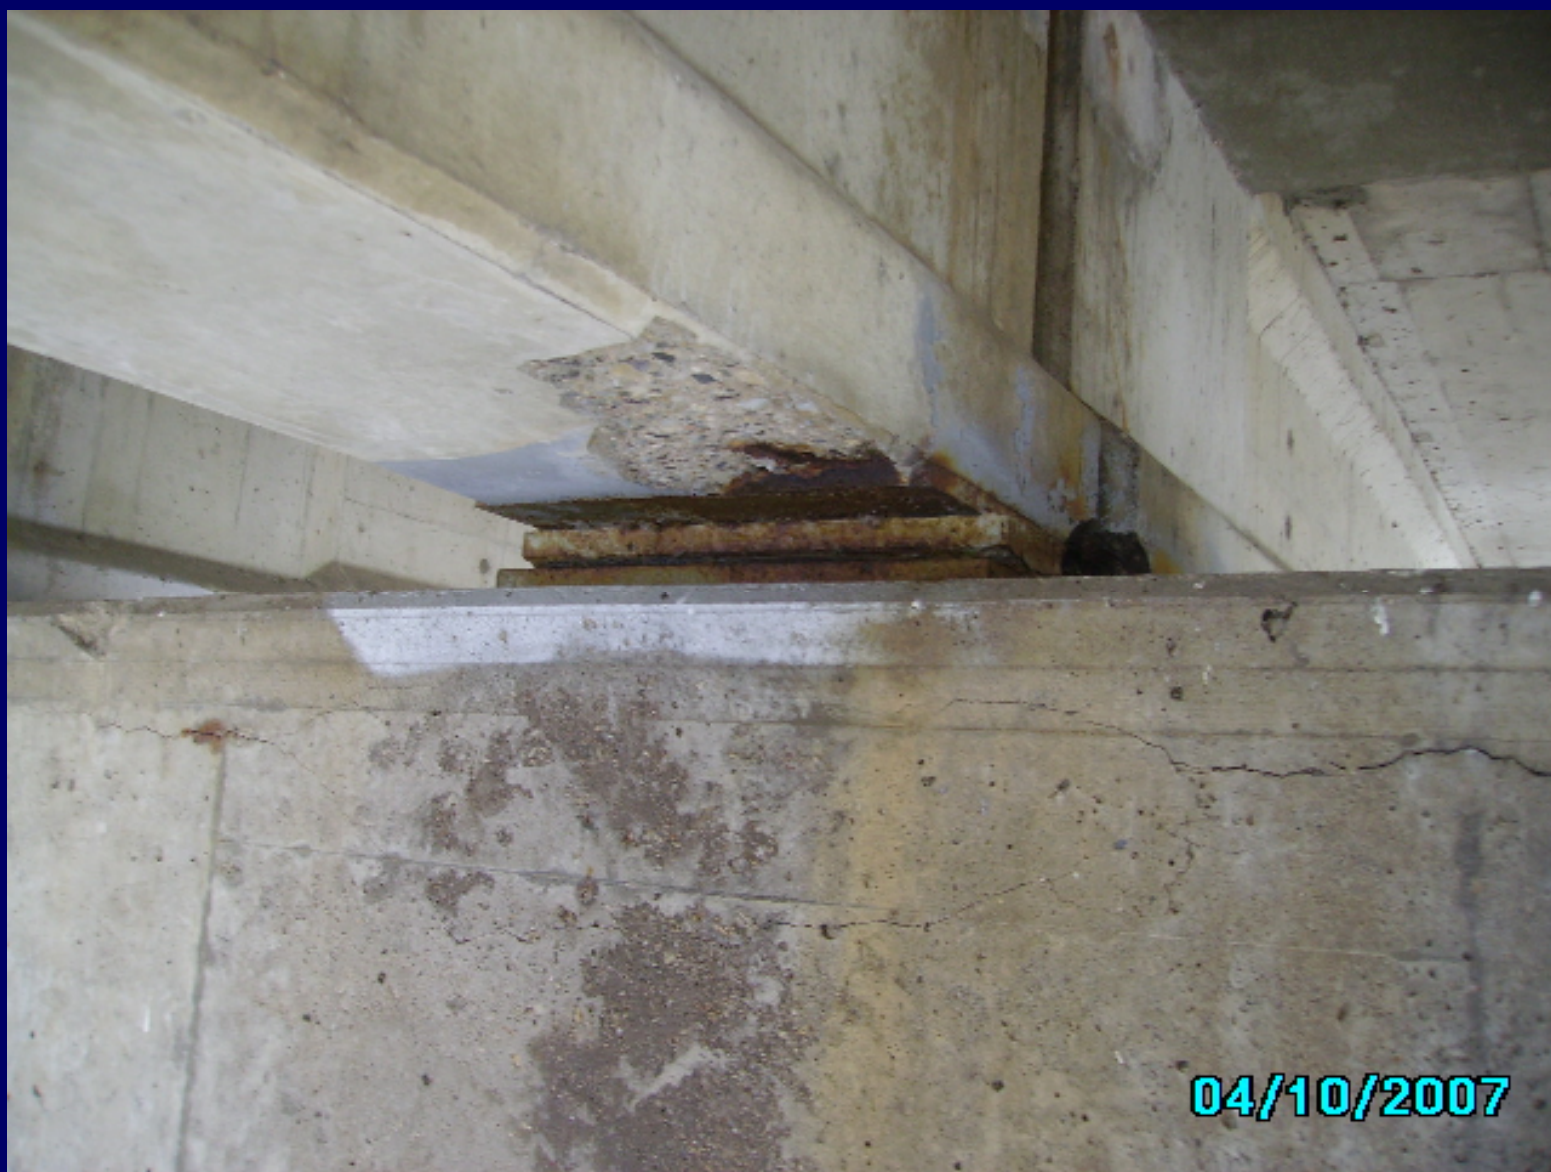
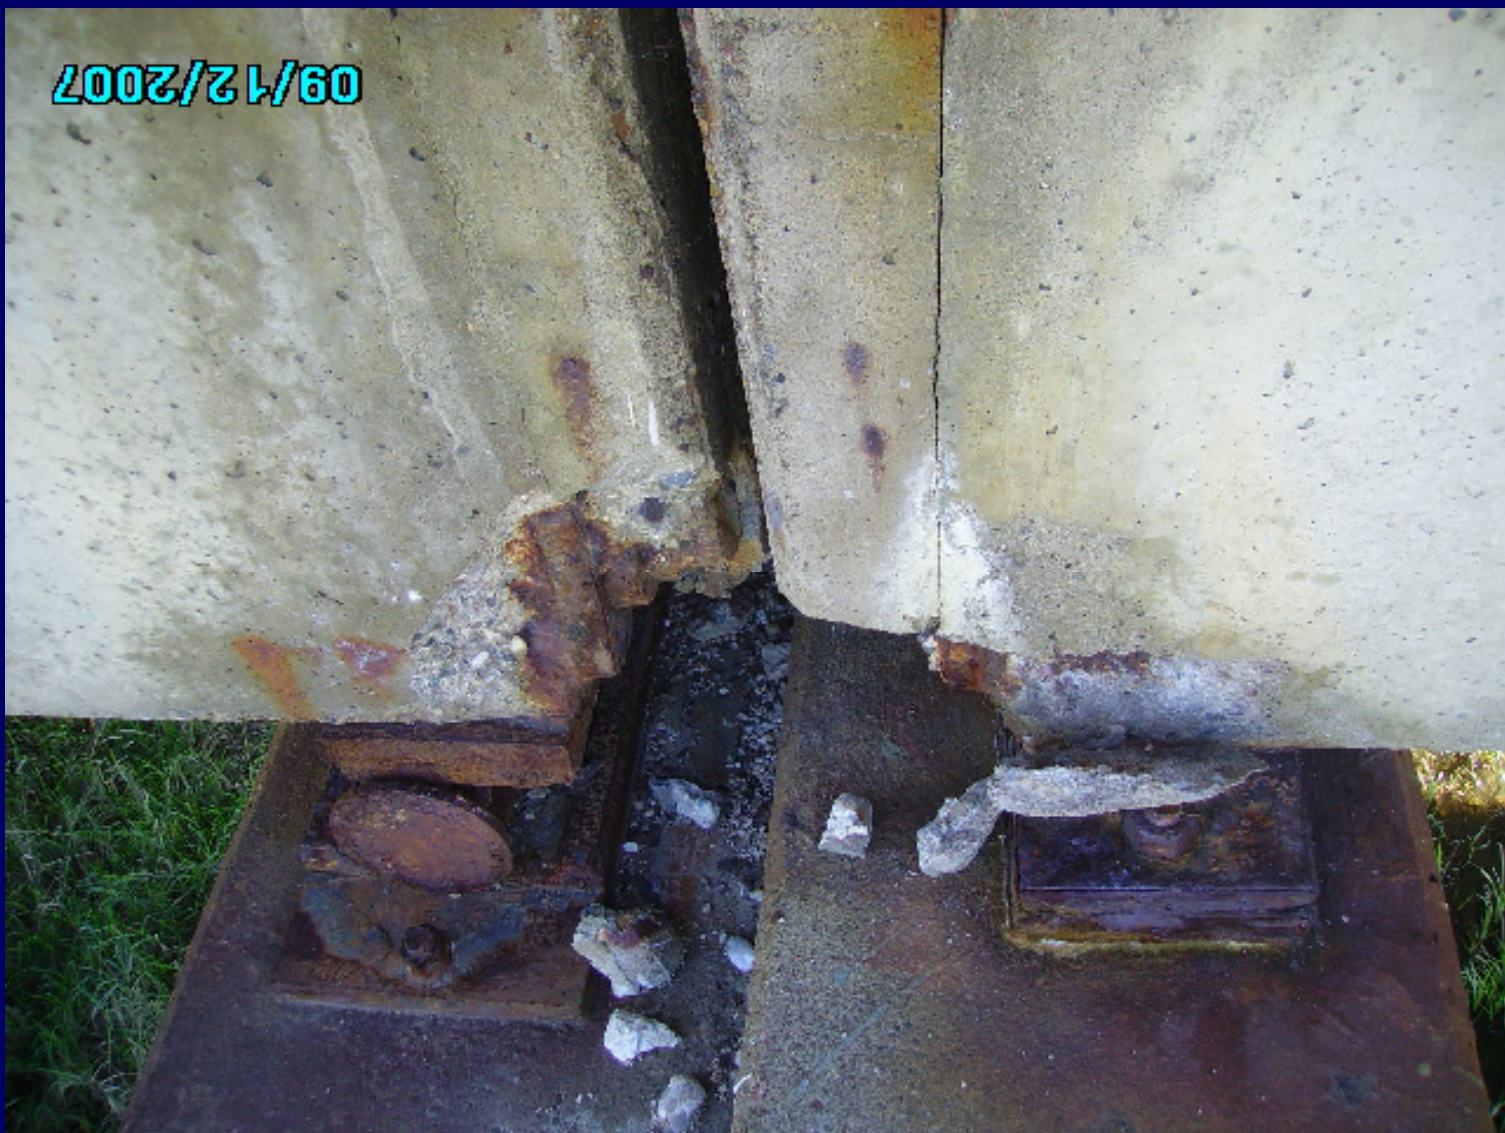
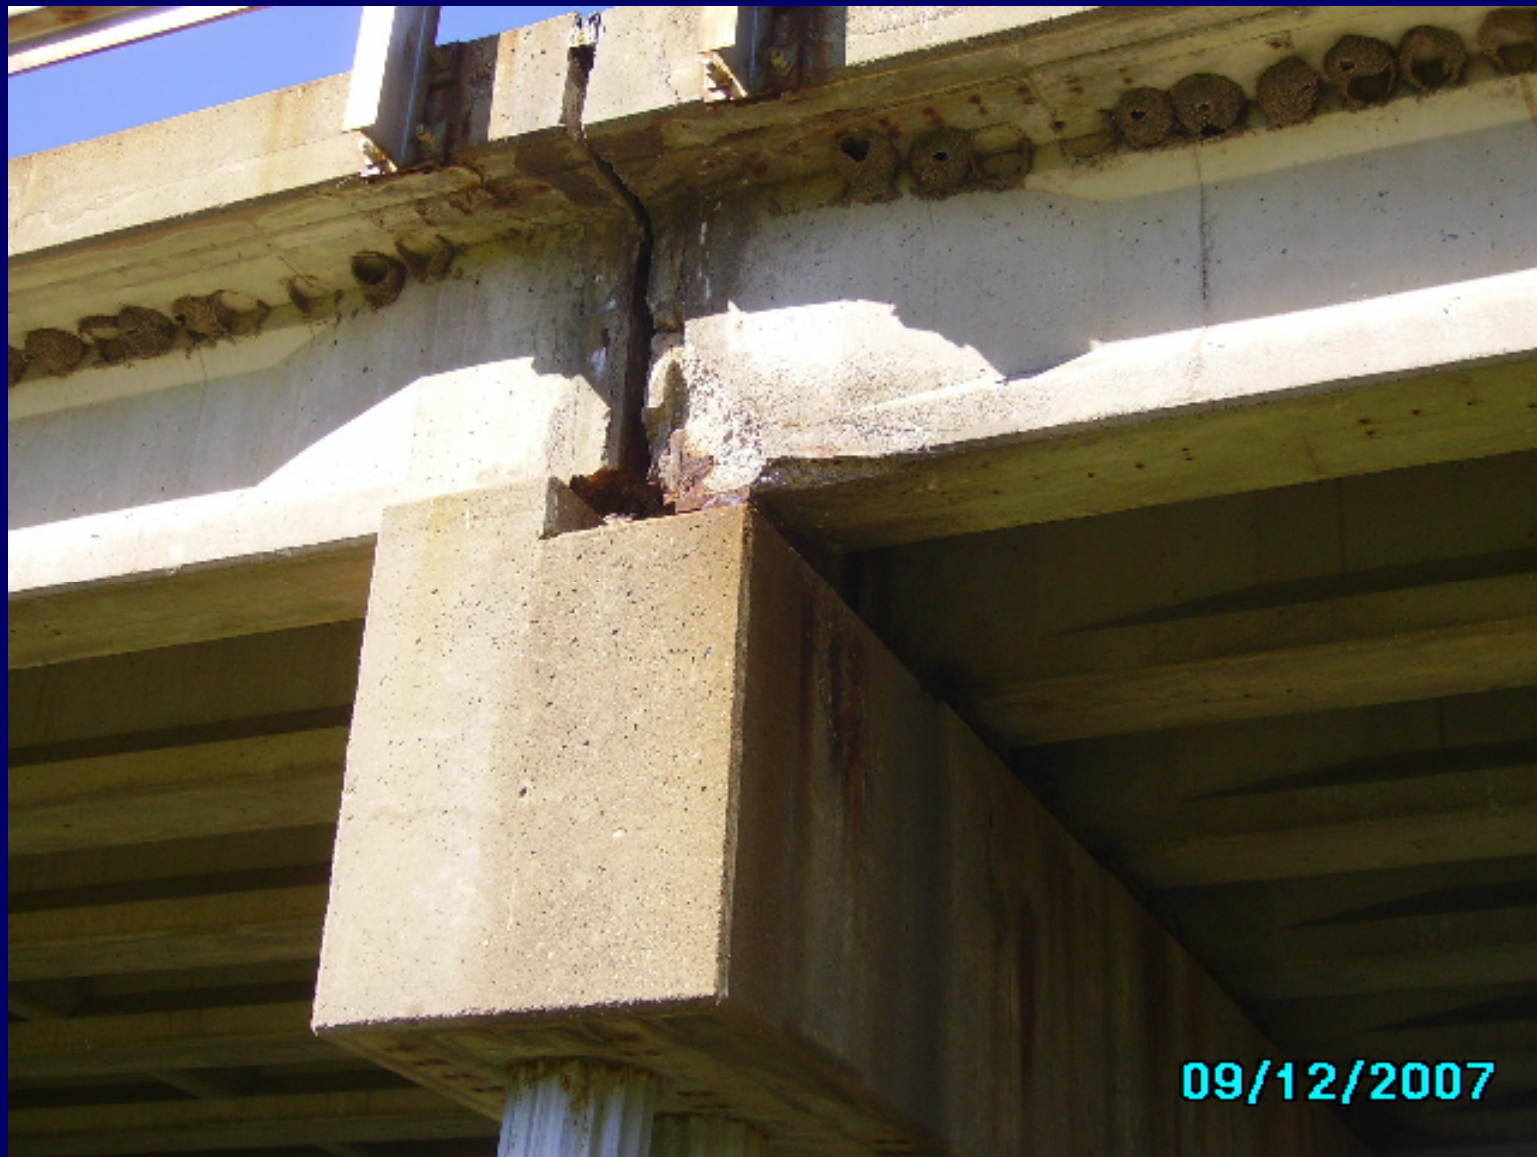
- The following slides will show some of the things we were seeing at our beam ends and the problems of salt infiltration not only cosmetically but eventually structurally as well.

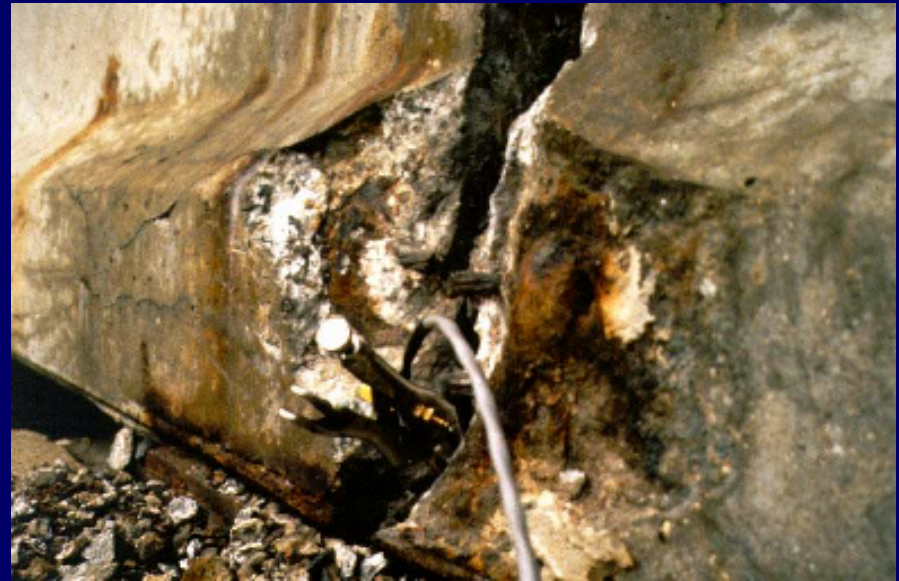
Points of Concern

- Repair: complete removal followed by reconstruction
- Common Issues:
 - ◆ Reoccurring spalls due to inadequate bond
 - ◆ Contaminants in adjacent areas migrate to the repair region

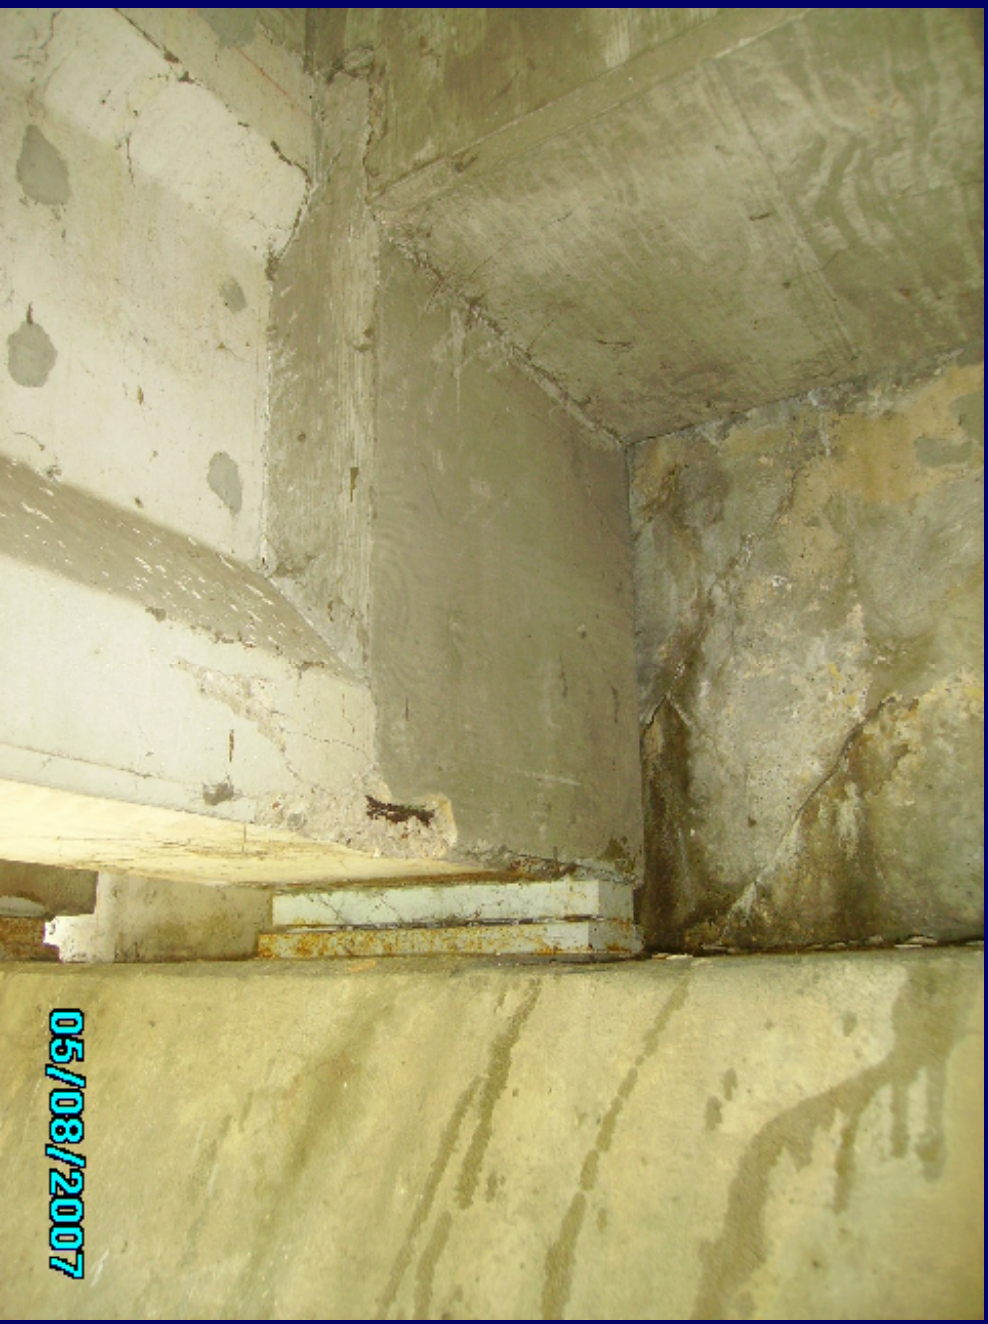
What We Were Doing:

- Spending many dollars and man hours on cleaning and patching with cementitious materials.
- Damage was already done and by patching we only created a cosmetic solution that only lasted a few years.
